**Docket No. 217 – Development and Management Plan Inspection**

**Date:** August 3, 2006

**Location:** Transition Stations: Hoyts Hill, Archers Lane, Norwalk Junction

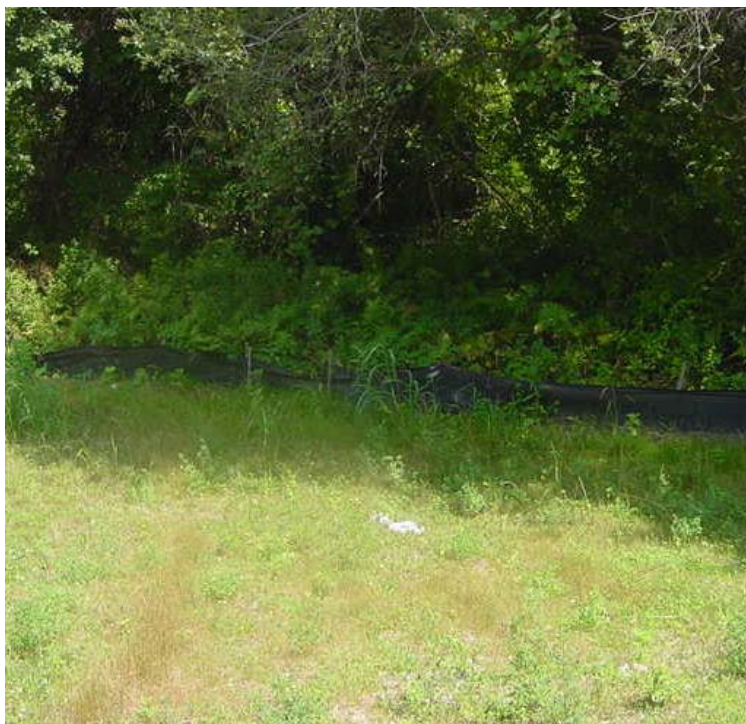
Erosion and Sediment Controls	<p>-<b>Hoyts Hill:</b> The perimeter silt fence along the wetlands at the rear of the station remains in good shape. 4/6-7/26/06.</p> <p>- The areas where the</p>	<p>-Monitor and maintain the fence as necessary. 4/6-7/26/06 Vegetation is growing very well in the adjacent wetland 7/26/06</p> <p>- Consider seeding to</p>	<p>- N/A</p> <p>- Needs evaluation</p>

Hoyts Hill Transition Station: Photo on the left shows a view of the electrical work at the station pad. Photo on the right shows the silt fence in place along the edge of the wetlands. 8/3/06

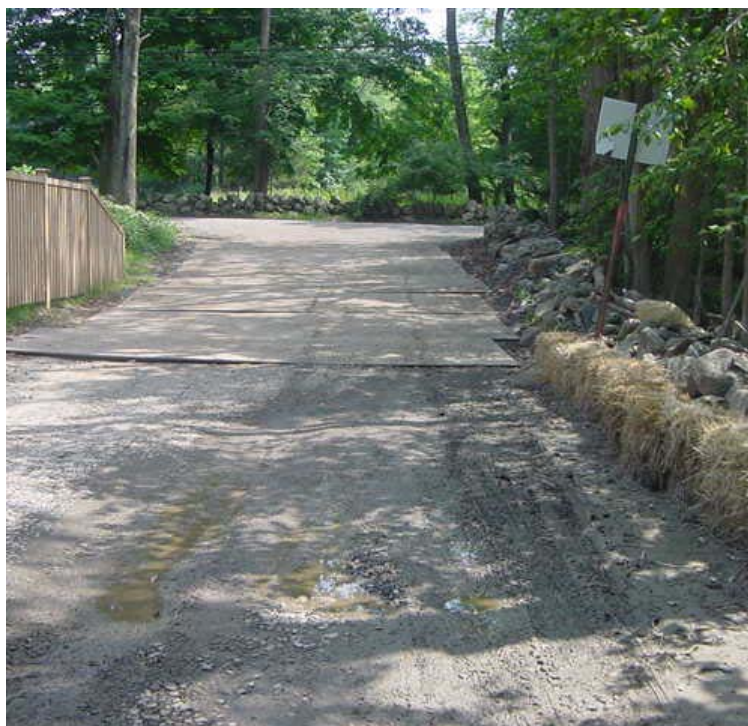
Archers Lane: Photo on the left shows the entrance off Diamond Hill Rd. Trench plates were in place and haybales had been added to the stone wall where water had been pooling. Photo on the right shows an overview of the work and structures in the station yard. 8/3/06.

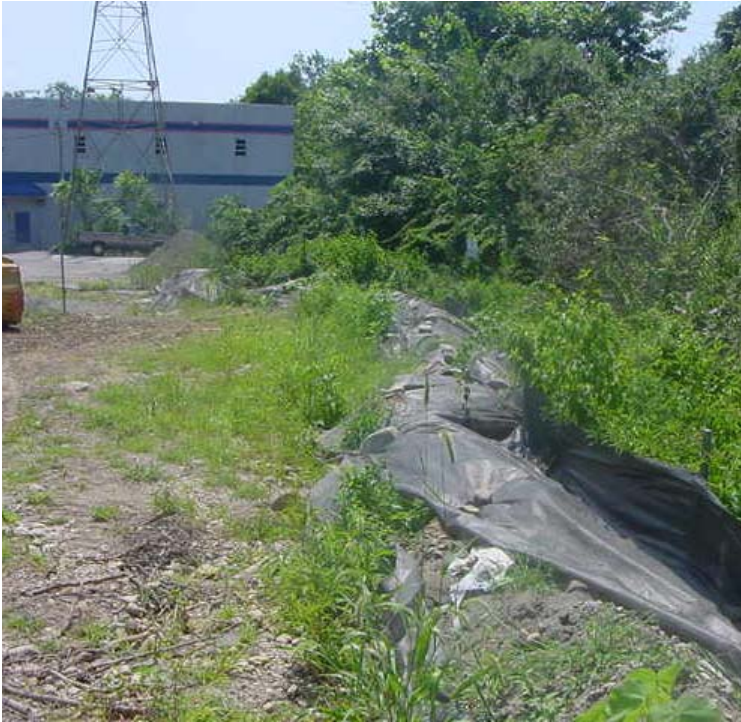
Norwalk Junction: Photo on the left shows the berm (non project related) along the perimeter silt fence. Photo on the right shows the degraded haybales remaining in the swales. New haybales were going to be placed here the day of inspection. 8/3/06

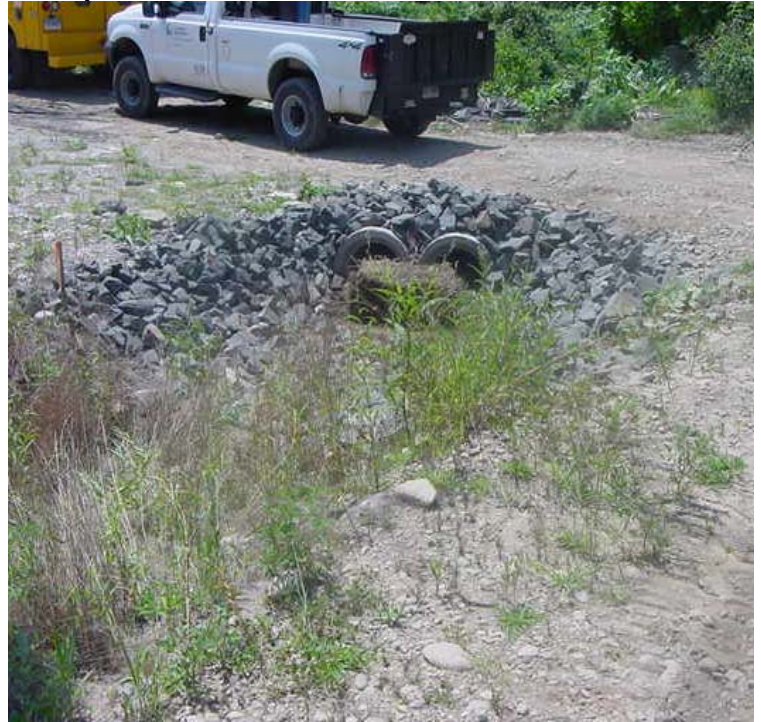
Areas of Inspection	Observation	Recommended Action	Corrected Actions
	7/26/06 -Silt is also building up in the spot closest to the river. 7/26/06	at the stone outlet and should be removed by hand. 6/1-7/26/06	
Erosion and Sediment Controls continued	<p>- All the haybales in the swale culverts remain degraded. 6/28-7/26/06</p> <p>-Significant sediment accumulation also remains in the swale. 6/7-7/26/06 Adjacent areas on site are not stable or have soil disturbance leading to additional sediment in the swale. 7/19-7/26/06</p> <p>- Significant ruts from equipment were noted adjacent to the perimeter fence. 7/26/06</p> <p>-Trench plates remain over the swale for access. 7/12-7/26/06</p>	<p>-Place new haybales or additional controls at all the culverts for filtration. 6/28-7/26/06</p> <p>- Continue to improve water quality to the swale by restoring areas wherever feasible. Also remove accumulated sediment from the swale 6/1-7/26/06.</p> <p>- Repair ruts and consider using mats or plates in this area to reduce disturbance. 7/26/06</p> <p>- The swale is intact at this time but if access causes any damage to the swale it should be repaired. 7/26/06</p>	<p>- Needs attention</p> <p>- Needs attention</p> <p>- Needs attention</p> <p>- N/A at this time</p>
